## Swanworth Quarry Extension

**Client:** Suttle Stone Quarries

### Project Detail

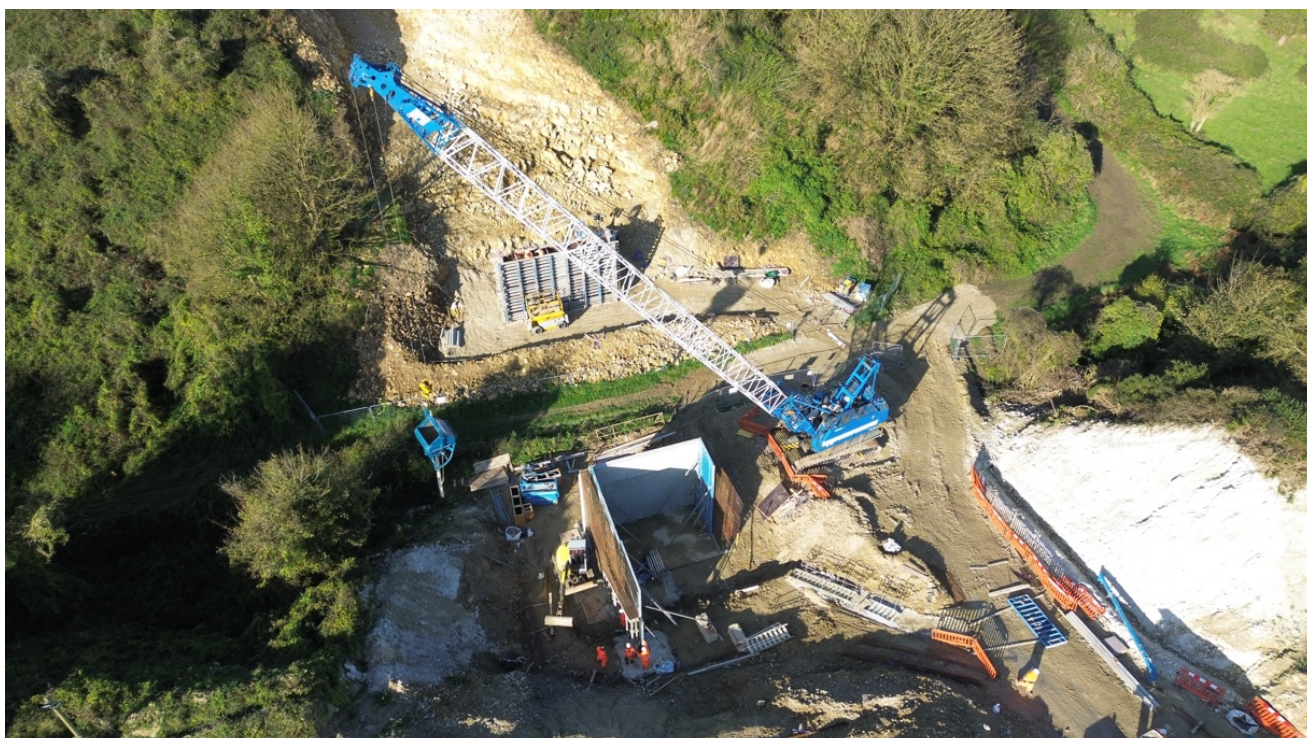
Figure 1: A drone view of the formwork being cast for the bridge abutments.

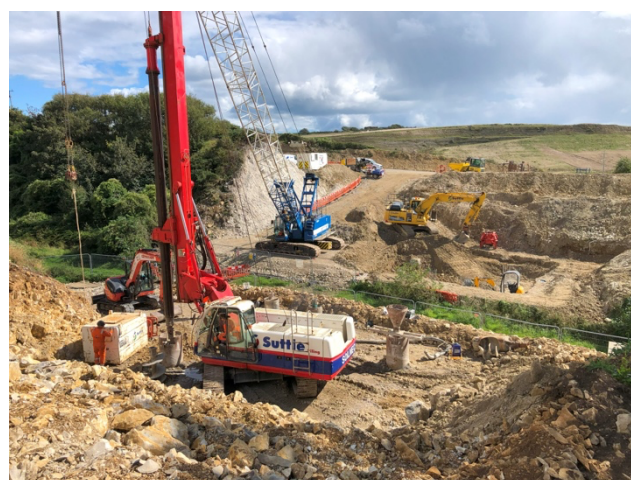
Figure 3: Rotary bored piling works.

- During the piling works we encountered the rock at a much higher level than the ground investigation bore holes suggested, this meant that we could not get past this level. To solve this problem we sourced a rock core barrel that fits onto the piling rig for the purpose of coring through hard rock. This worked successfully and allowed us to get down to our pile design level.

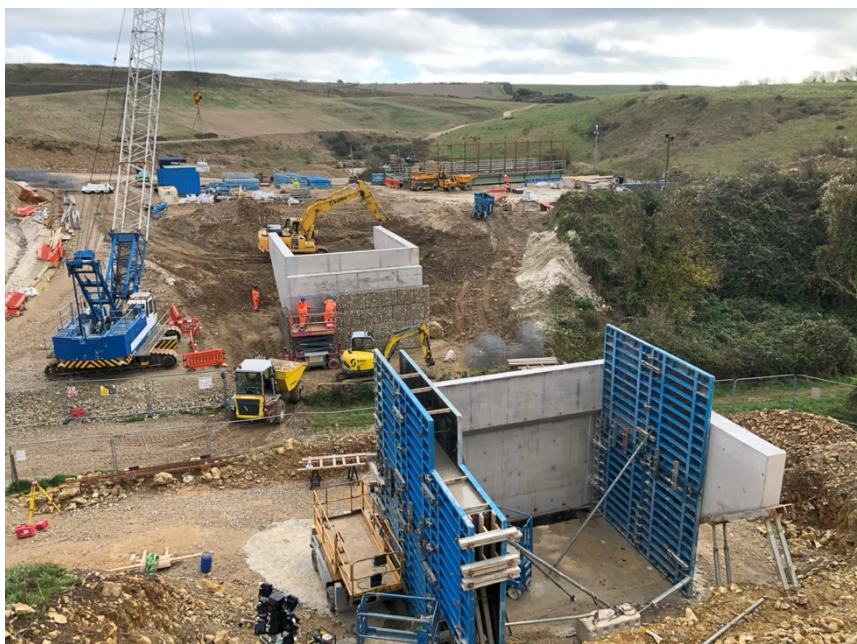
Figure 4: Reinforced concrete abutments and gabion cladding.

The limestone aggregates that were used for the backfilling and the gabion stone used for the gabion basket cladding were sourced directly from the quarry, avoiding the need to import materials to the site.

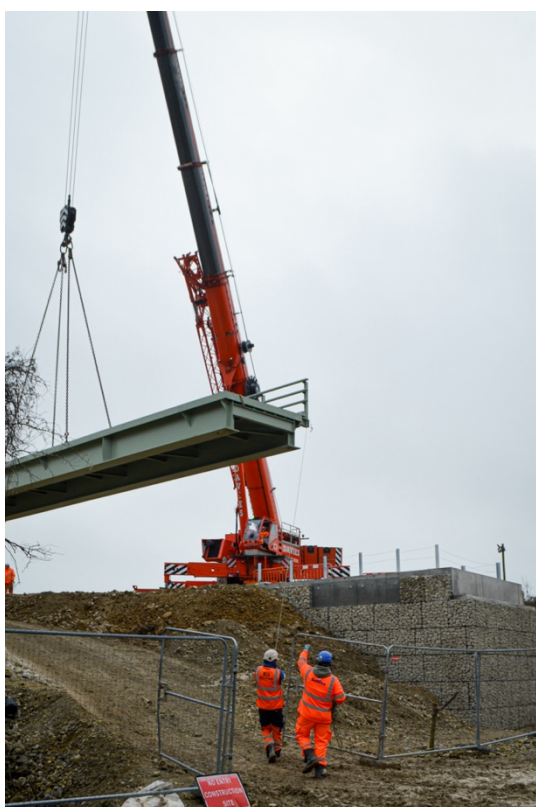
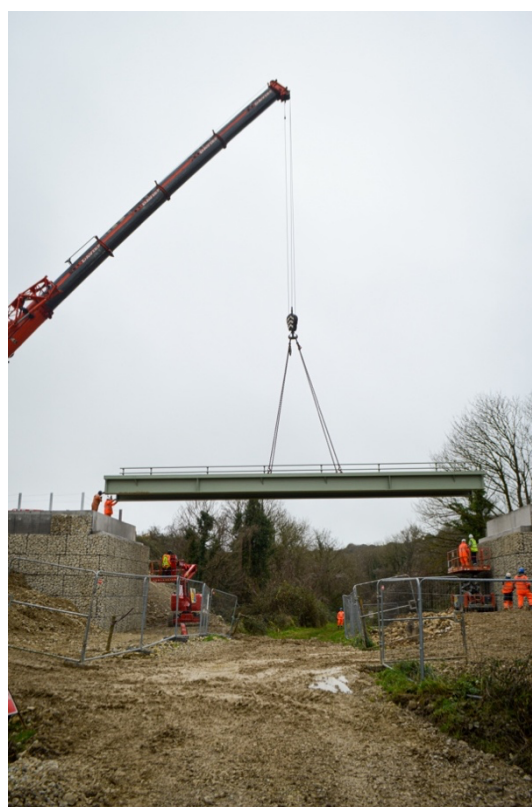
Figure 5&6: The first of the two 21.4m bridge decks being craned into place.

An important part of the planning application was that the bridleway would not be closed during construction works. This was achieved successfully, with enclosed working areas on each side of the bridleway to facilitate the construction of the 2nr abutments; the bridge decks were subsequently lifted into place from the existing quarry side.

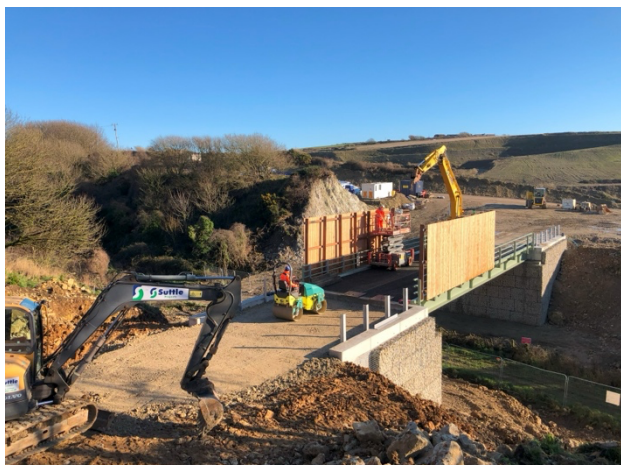
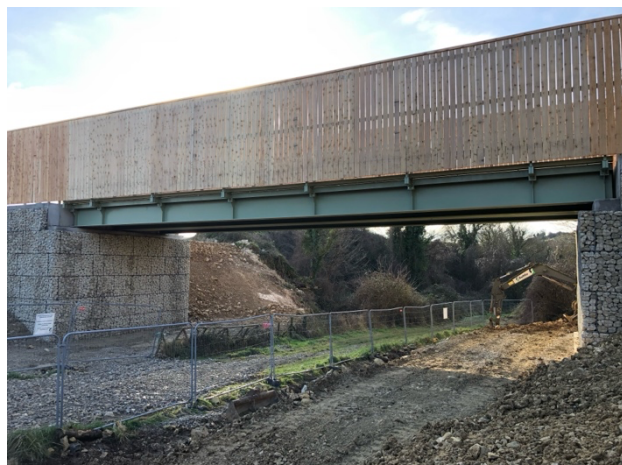
Figure 7&8: Installation of timber cladding and backfilling north abutment carriageway.

- The central sections of the visual screening cladding were too big and obstructive to fix in place on the bridge before it was installed, but would take a long time to fabricate once the bridge was in place. This problem was solved by pre-assembling 8nr large panels which were then lifted into position from the carriageway once the bridge decks had been installed.

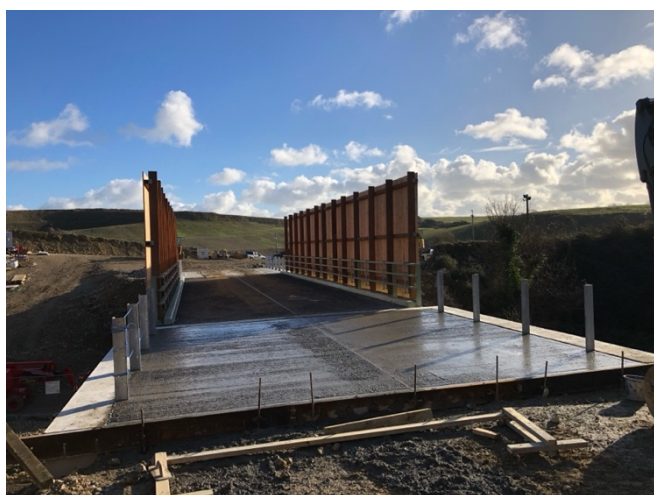
Figure 9: The concrete pad on one side of the bridge

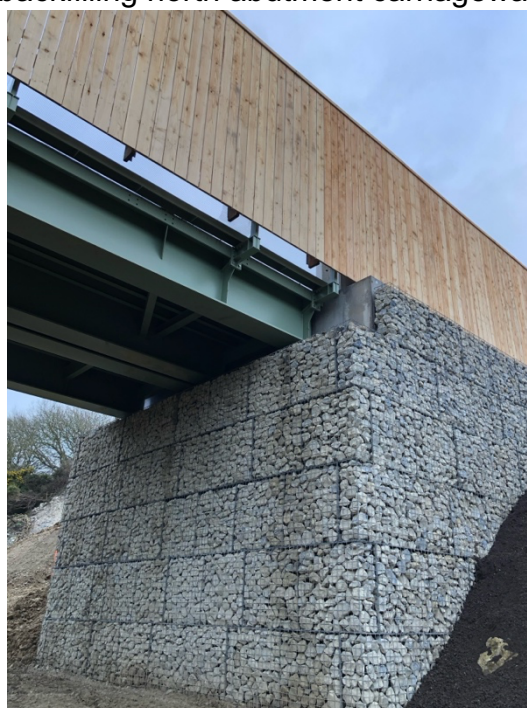
Figure 10: The abutment having been clad in the gabion stone
