## **West Bay Sea Wall Repairs**

**Client:** Dorset Council

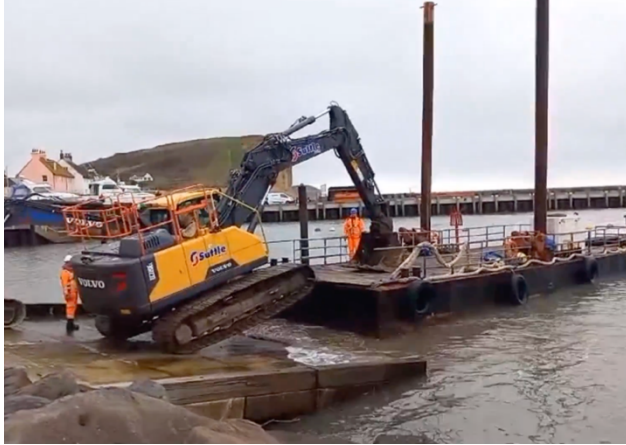
Figure 1: A still taken from footage of the excavator boarding the cargo barge.

Using our Volvo EC220 excavator fitted with a Movax attachment, we installed 84 sheet piles from the water. To provide a stable working platform, we mobilised a JML60 Deck Cargo Barge; a shallow-draft, flat-bottomed vessel equipped with two 12-metre self-elevating spud legs for accurate positioning. The excavator was loaded onto the barge at the East Pier before being transported through the harbour to the work area.

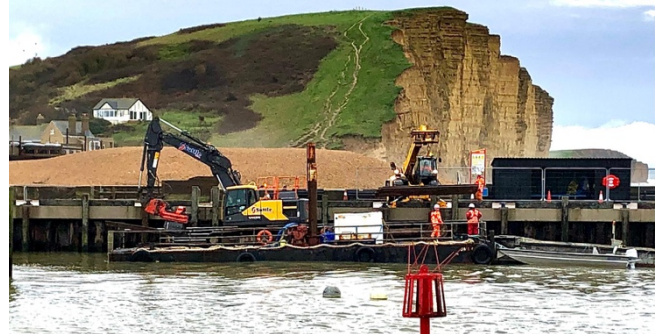
Figure 2: The cargo barge in place with the excavator carrying out the piling works

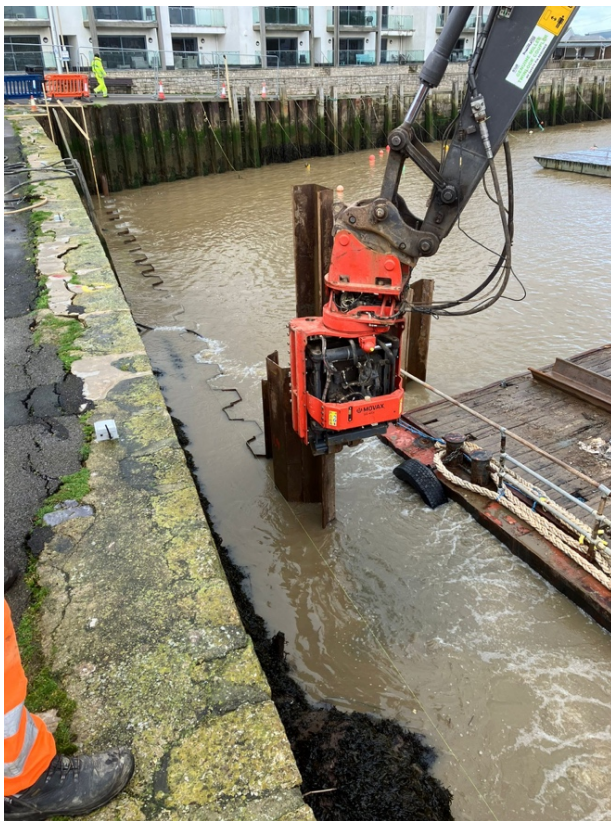
Figure 3: The Movax attachment pushing in the sheet piles

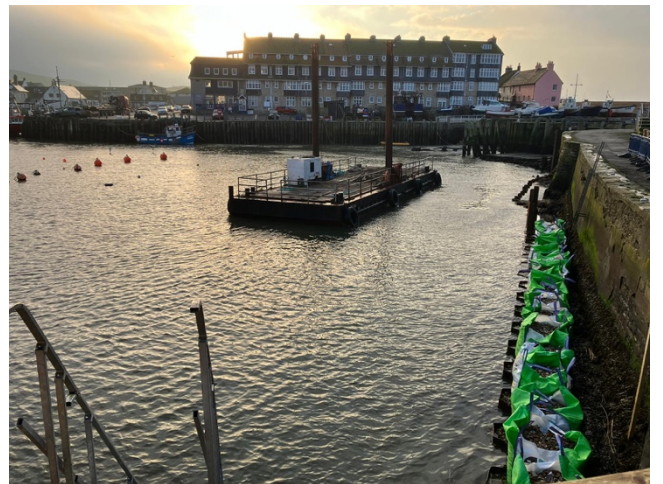
Figure 4: The completed sheet piling works which have then been backfilled with stones.

The harbour wall was successfully stabilised, with all sheet piling works completed ahead of programme and without incident. Through careful planning, specialist marine equipment and experienced operatives, Suttle Piling delivered a safe, efficient and environmentally responsible solution with minimal disruption to harbour operations.
