## **Southsea Timber Groyne**

**Client:** Boskalis Westminster

### **Project Detail**

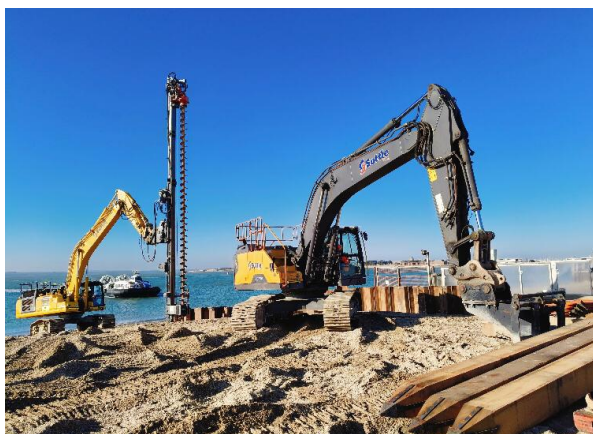
Figure 1&2: Pile installation & Auger Works

The works made extensive use of our 50T and 30T excavators with Movax attachments. Specifically our Movax SG65v and our proprietary MPL auger. The use of the MPL proved particularly advantageous, offering enhanced manoeuvrability and flexibility compared to conventional leader rigs. This allowed for more efficient pre-drilling operations within the variable beach conditions.

Our 50T excavator, equipped with our MPL auger attachment was able to predrill pile locations to allow for easier installation of the timber piles with the 30T equipped with our MOVAX SG65v attachment. Due to the nature of these works, special adaptations must be made to the jaws of the hammers to

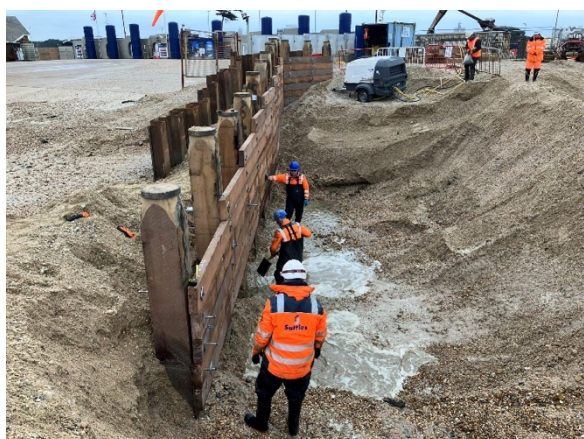
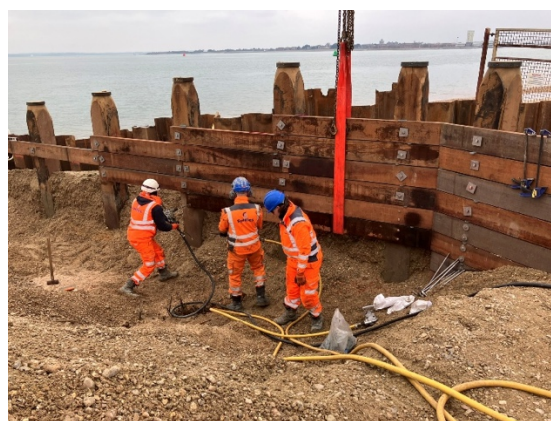
Figure 3&4: Planking

The planking work on this project extended to depths of 2.5m below beach level, our experienced planking team have prior experience working in this environment and were able to work effectively and efficiently to deliver the works within a narrow spring tide window.

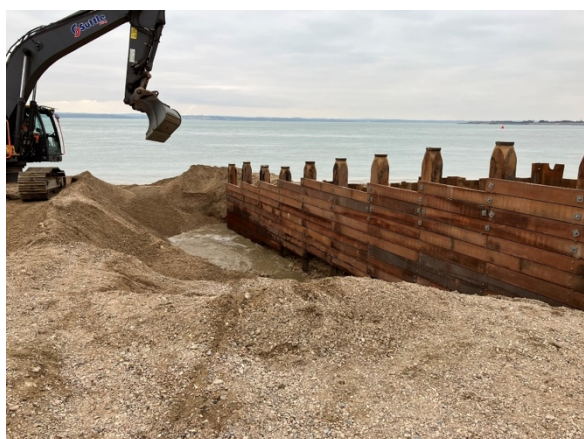
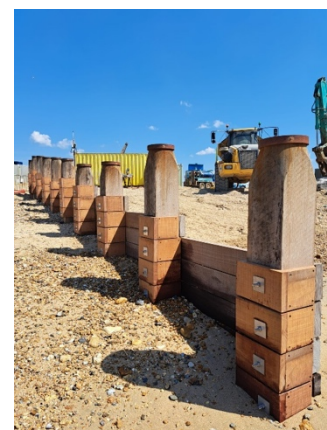
Figure 5&6: The finished works

The works involved the installation of a temporary sheet pile retaining wall, followed by the construction of a thirteen-pile, angled timber groyne.
