## **Sterte Channel Refurbishment Works**

**Client:** BCP Council

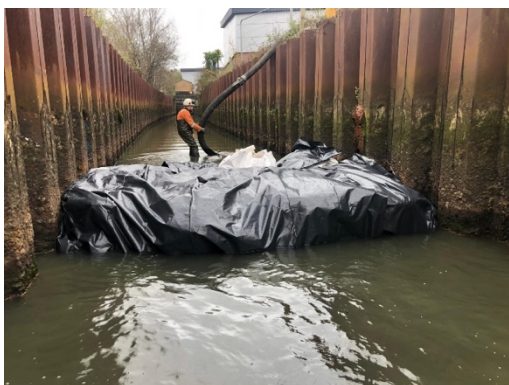
Figure 1: A temporary dam used to create a dry working area.

The refurbishment works were delivered through a carefully planned, phased approach. Vegetation was cleared to provide safe access before a temporary dewatering system was installed, using temporary dams and pumping arrangements to create controlled dry working areas while maintaining the channel's flow.

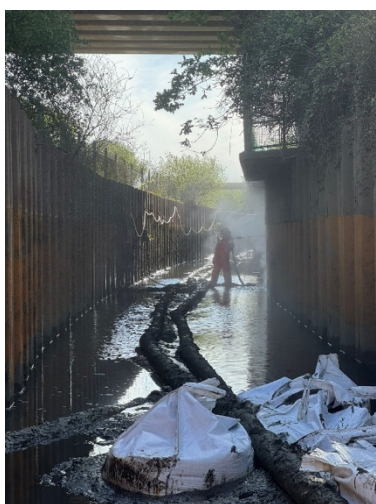
Figure 3: The protective cementitious epoxy coating system being spray-applied to the sheet piles

Following the repairs, a protective cementitious epoxy coating system was spray-applied to the sheet piles, with interlocks also filled to provide long-term corrosion protection and extend the operational life of the asset. Additional activities included debris removal, silt management to maintain access, and localised cutting of corroded sheet piles at the outfall structure to eliminate unsafe edges.

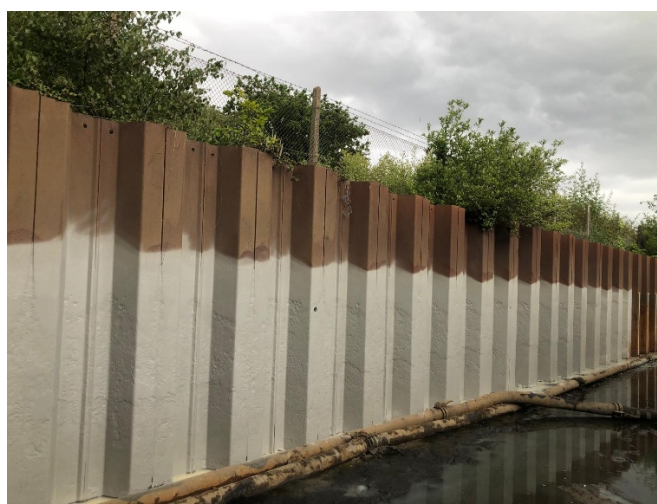
Figure 4: The refurbished sheet piles

The refurbishment works successfully restored the condition of approximately 400 metres of sheet pile wall, extending the operational life of this critical drainage asset and helping to protect the surrounding infrastructure from future deterioration. By refurbishing the existing structure rather than replacing it, the project delivered a more sustainable solution, reducing material consumption and maximising the lifespan of the asset. The carefully phased dewatering strategy and specialist repair techniques demonstrated the creativity required to work safely within a live drainage environment while maintaining channel flows. Efficient planning and coordination enabled the project to progress smoothly with minimal disruption, reflecting our commitment to productivity, while the high standard of workmanship and durable corrosion protection system reinforced the reliability our clients expect when delivering long-term infrastructure maintenance solutions.
